CASCADIA GEOSERVICES, INC.

Preliminary Geologic Site Assessment
Coquille Indian Tribe Land
Miluk Drive
Coos Bay, OR 97420
CGS Project No 18059

Photographic Log

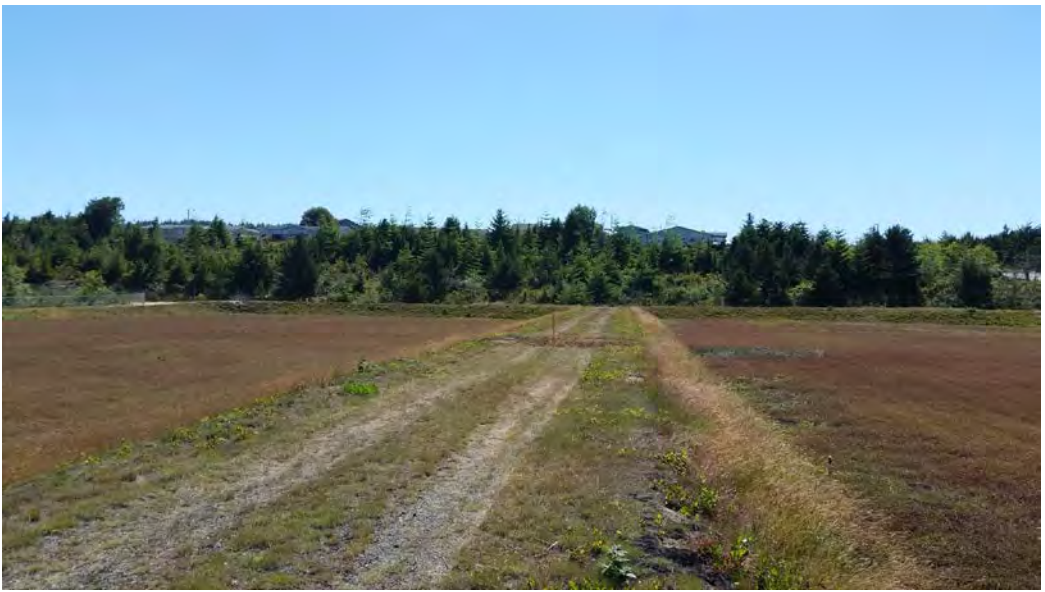
Photo No: 1

The site is within the Coast Range Physiographic region of southwestern Oregon. It is located on a gently west sloping marine terrace located east of and elevated above the Coos River. Based on our review of historical aerial photographs, the site was leveled as part of the development of a cranberry farm sometime between 1994 and 2000. According to the site plan provided, the medical facility building will be located on an existing bog and dike and the and the proposed parking area will be located on the bog to the south (Photo 1).

The site looking east.
 Note staked location of Test Pit 2

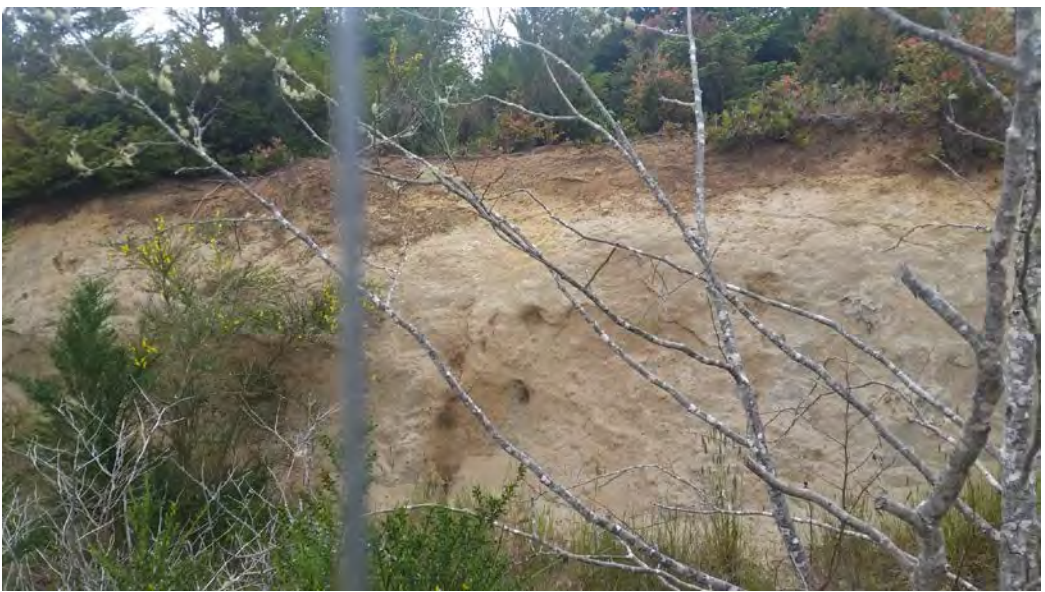
Photo No: 2

Cut slope east of the site.

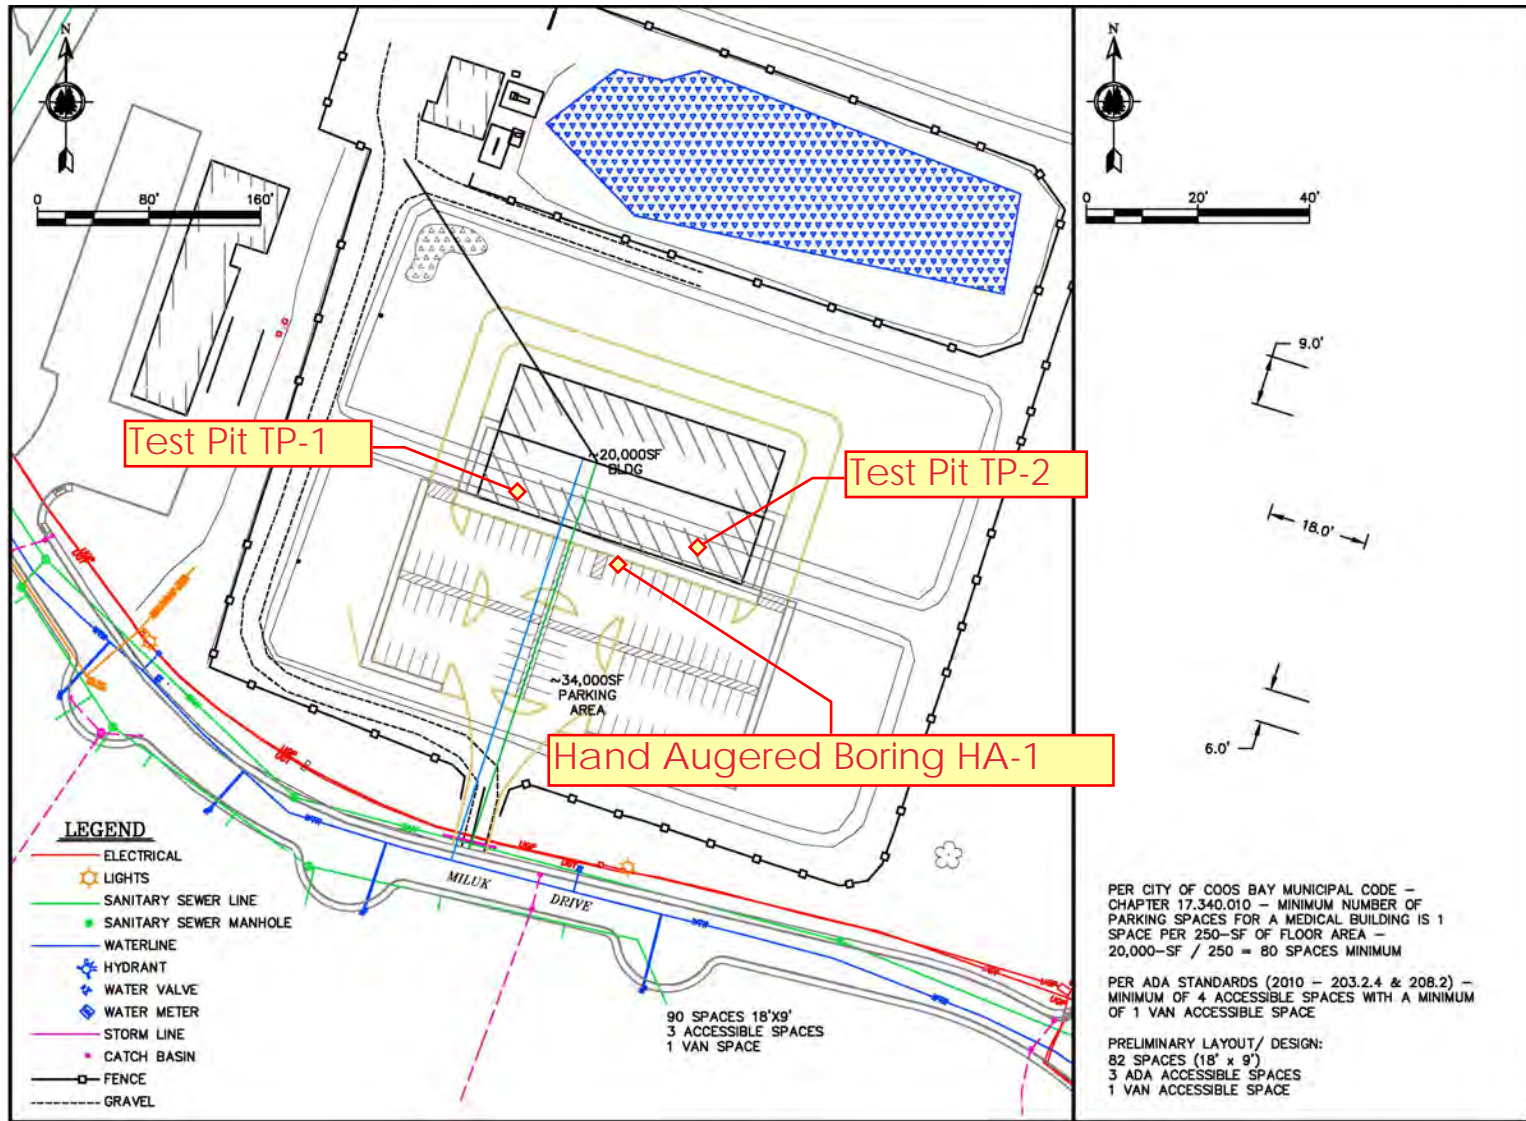
Figure
2

The test pits were observed by a Certified Engineering Geologist from our Port Orford office. The test pits were logged, groundwater observed and samples collected. Figure 2, Site Map shows the location of the test pits and hand augered boring.

Hand Augered boring HA-1 was drilled at the base of the dike of the cranberry bog (see Figure 2). From 0.0 to 2.3 feet bgs, HA-1 encountered soft brown-gray organic silt and clay: damp. At 2.3 to 4.0 feet bgs, HA-1 encountered loose, dark brown clayey fine sand: wet. We infer that this is fill placed in the cranberry bog.
